**Re: Transmittal of Compliance Evaluation Inspection Report
Municipality of Luquillo Small Municipal Separate Storm Sewer System
NPDES Permit Number PRR040066**

Compliance Evaluation Inspection

Facility Name: Luquillo Public Works Facility
NPDES Permit Number: PRR040066
Inspection Date: September 10, 2013

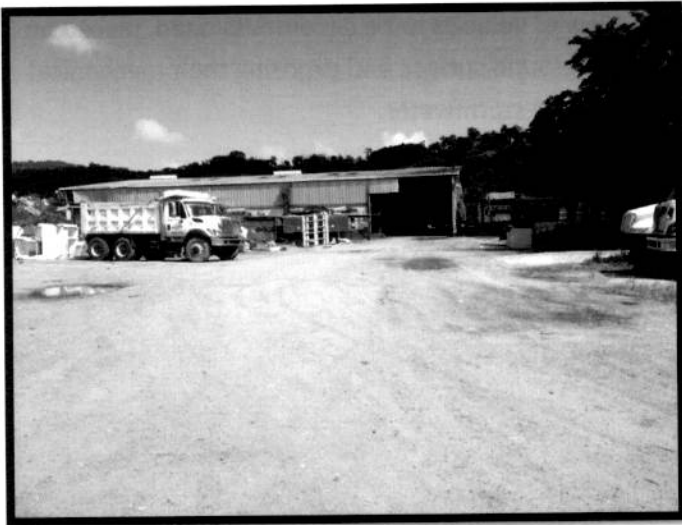
Picture 1

1. The stormwater runoff from the Workshop and its soundings flows through the ground surface down gradient towards the concrete road that connects to State Road #991. The stormwater runoff from the open dump site flows through the ground surface down gradient towards the concrete road that borders the facility at the south side. Refer to the map on Attachment II for a view of the drainage system.

View of the workshop. The stormwater runoff in this area flows from the workshop area towards the entrance of the facility.

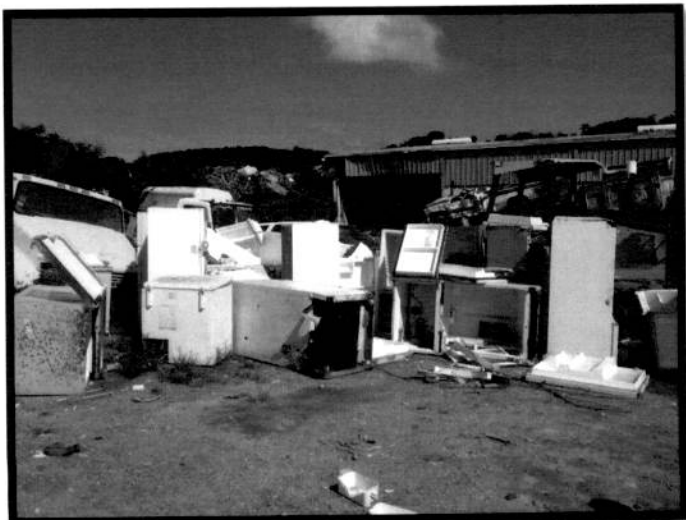
Picture 3

Electric appliances collection area. The equipment was placed on the ground surface and exposed to stormwater.

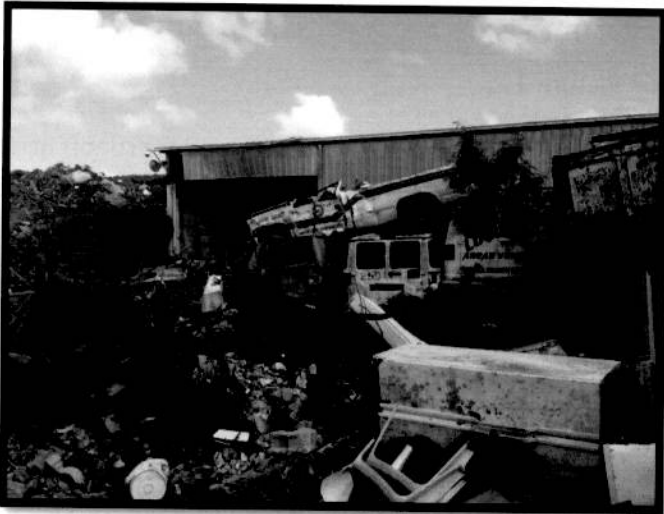
Picture 4

2. Various vehicles and equipment to be decommissioned were placed around the mechanical workshop. The vehicles and equipment to be decommissioned were exposed to storm water contact and several oil stains were observed. The pollution prevention practices typically employed at auto parts facilities had not been implemented. For example, multiple vehicles were not stored with the hood down (i.e., overhead coverage for engines and fluid residues), and other vehicles and metal parts had not been lifted off the ground (see pictures 4 and 5).

View of vehicles to be decommissioned, placed on the ground surface and exposing their mechanical parts to stormwater.

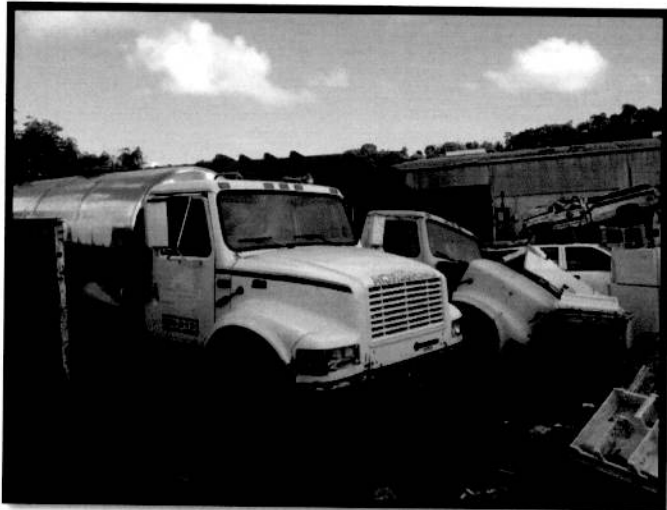
Picture 5

View of vehicles to be decommissioned placed on the ground surface and exposing their mechanical parts to stormwater.

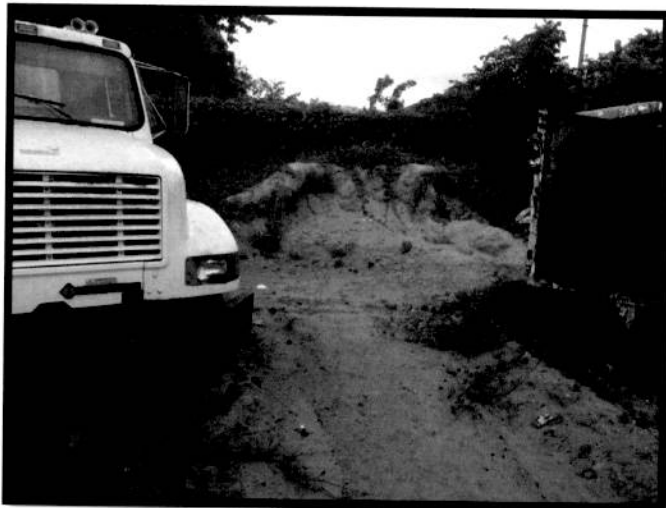
Picture 6

3. A sand stockpile was observed at the south side of the facility without erosion controls implemented (see Attachment I, picture 6).

View of sand stockpile without erosion controls.

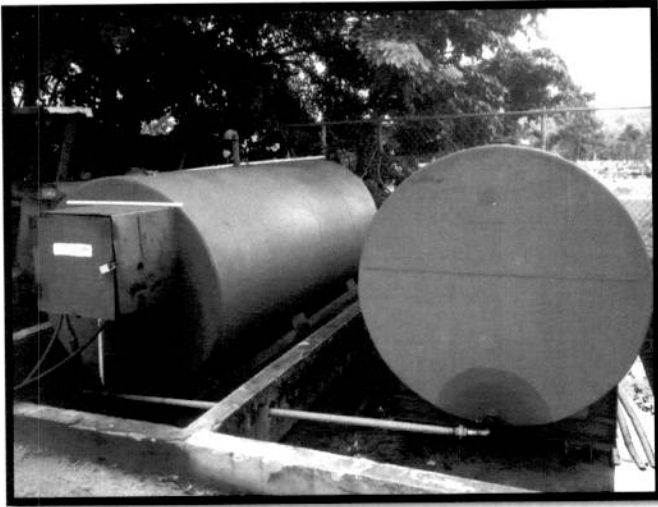
Picture 7

Diesel tanks dike were filled with stormwater, sediments, and debris.

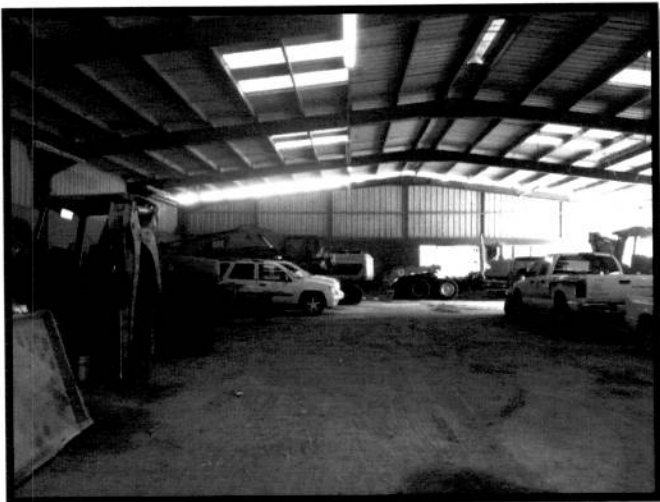
Picture 8

View of the mechanical workshop from the inside.

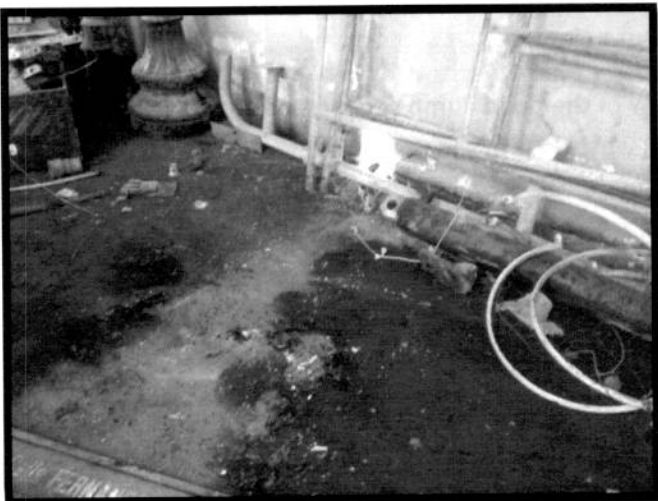
Picture 9

View of an oil stain at the workshop floor, close to an orifice in the wall, which can allow the spill to reach the ground surface outside the building.

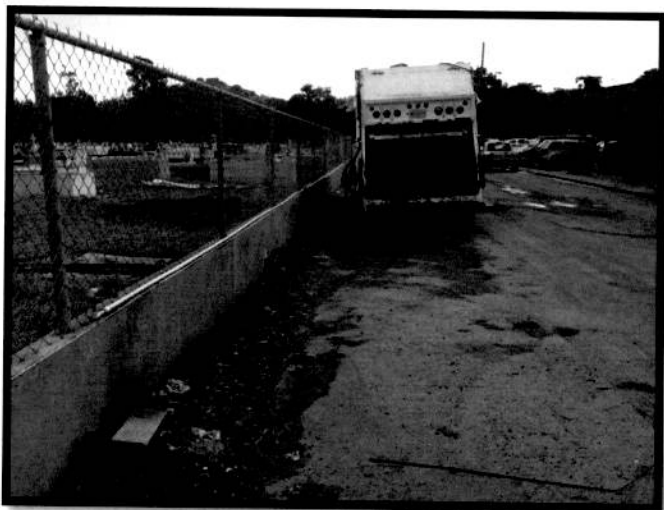
Picture 11

4. The diesel tanks dike was filled with water, sediments, and debris (see picture 7).
5. The vehicle washing area was located outdoors, on an impervious surface. No Best Management Practices (BMPs) have been implemented at the area (see picture 11). Municipal vehicle washing can generate dry weather runoff contaminated with detergents, oils, grease, and heavy metals. Vehicle washing BMPs can eliminate contaminated wash water discharges to the sanitary system. Such BMPs include installing wash racks that discharge wash water to a sanitary system, and contracting the services of commercial car washes, which are permitted to discharge wash water to the sanitary sewer system. Finally, employees and subcontractors should be trained in the municipality's vehicle washing procedures to avoid illicit discharges.

View of the vehicle washing area, located on an impermeable surface.

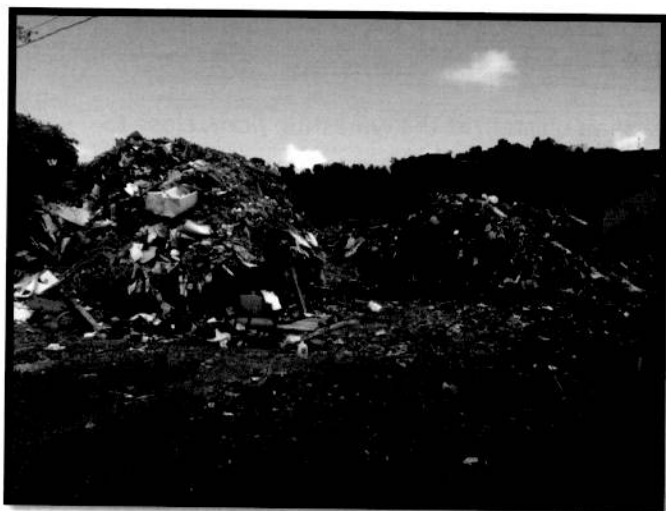
Picture 12

6. An open dump site was observed at the north and west sides of the Public Works Facility. According to Mrs. Rosa Rodríguez, the Municipality has been accumulating waste for approximately 25 years. The waste piles covered an area of approximately one acre and a half. The waste observed included households yard waste, wood pieces, scrap tires, auto parts, furniture, electric appliances, construction and demolition debris, and household trash, among others. No BMPs have been implemented and leakage was observed at the bottom of the piles. The waste piles located closer to the cemetery and the road were covered by vegetation. Mrs. Rodríguez explained that the area had been cleaned twice since the operation started and the last cleaning took place approximately 8 years ago (see pictures 12, 13, and 14).

Regardless of the permitting status of the dumpsite the EPA inspector did not observed Best Management Practices (except waste piles covered by mature vegetation) to reduce, minimize, or eliminate the discharges of polluted stormwater runoff coming from the dump site area.

View of the open dump site located at the north and west sides of the property.

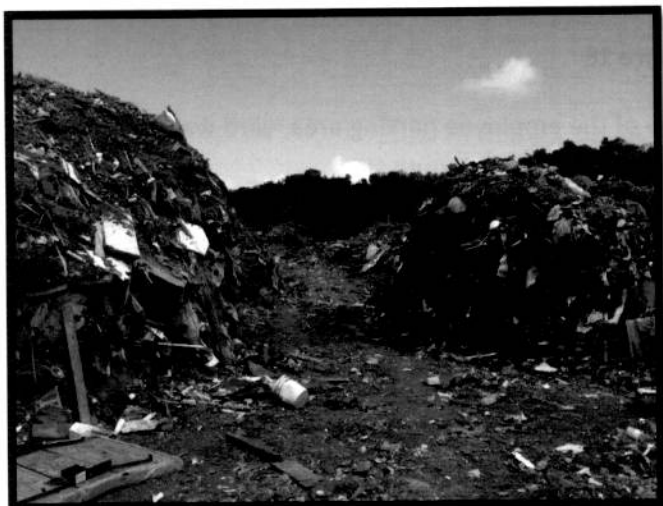
Picture 13

Closer view of the open dump site. The waste observed included households yard waste, wood pieces, scrap tires, auto parts, furniture, electric appliances, construction and demolition debris, and household trash,

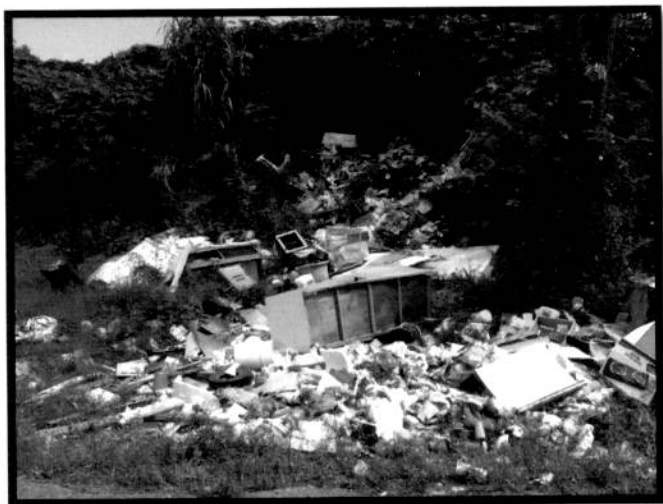
Picture 14

View of the waste reaching the concrete road. The stormwater from the open dump site flows into the concrete road that borders the south side of the facility.

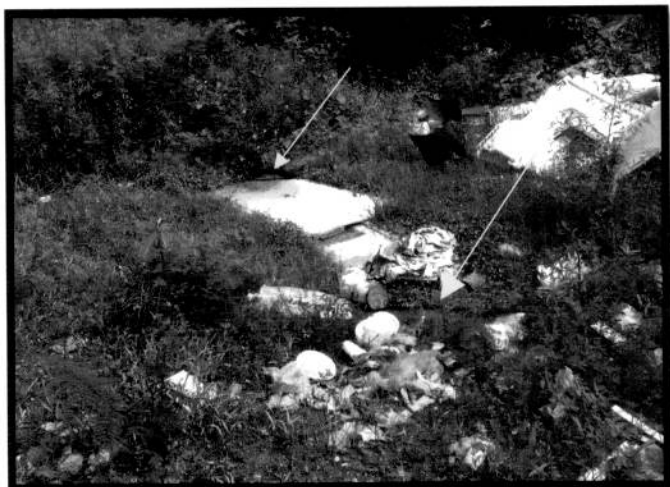
Picture 15

7. Yard waste piles were observed beside the employee parking area. According to Mrs. Rodríguez, the Municipality has a yard waste pick-up program and the materials collected were used to produce mulch. The grounding machine broke 4 months ago and the materials have been stored at this area (see pictures 15 and 16).

View of waste on the ground surface. This picture showed paint container, plastic bottles, plastic bags, and wood pieces. The arrow indicates a dark color liquid that looks like leachate.

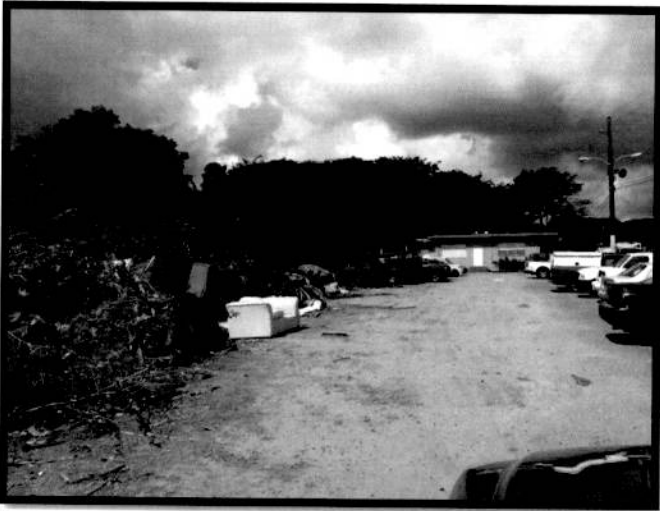
Picture 16

View of the employee parking area, yard waste was observed at the south side.

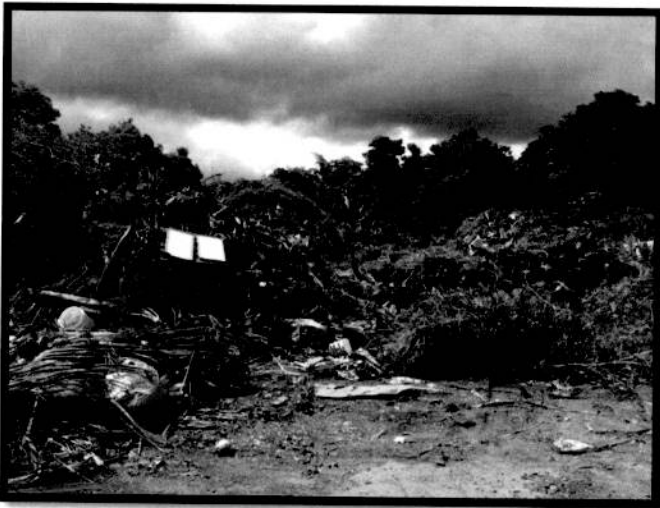
Picture 17

View of the yard waste accumulated at the east side of the property besides the office building and the employee parking area.
